US Army Corps
of Engineers®
Engineer Research and
Development Center

Laboratory and Field Evaluation of In-Place Asphalt Recycling Technologies for Small Airfield Repair

June 2013

Final report

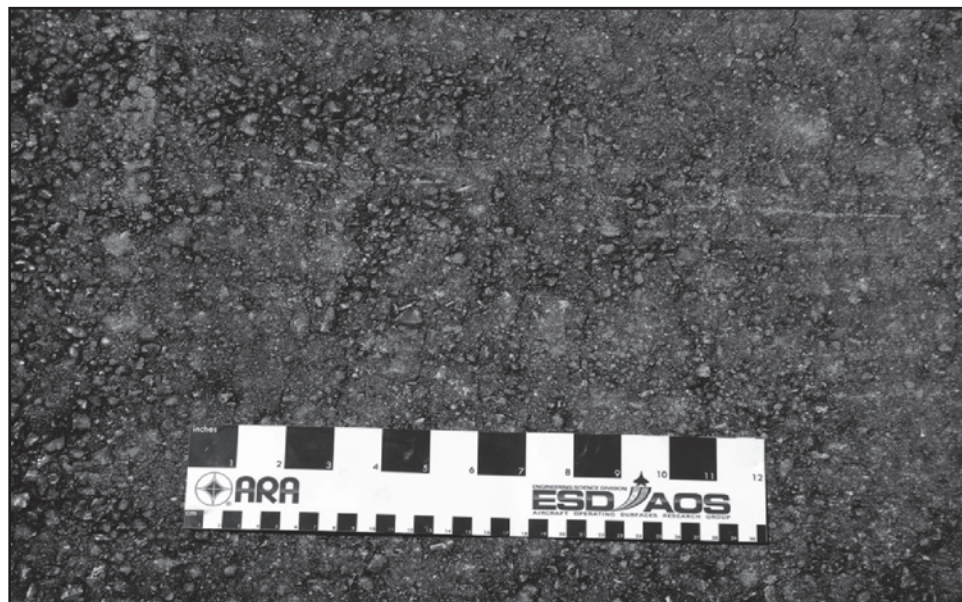
Figure 59. Surface cracking (PD-3).

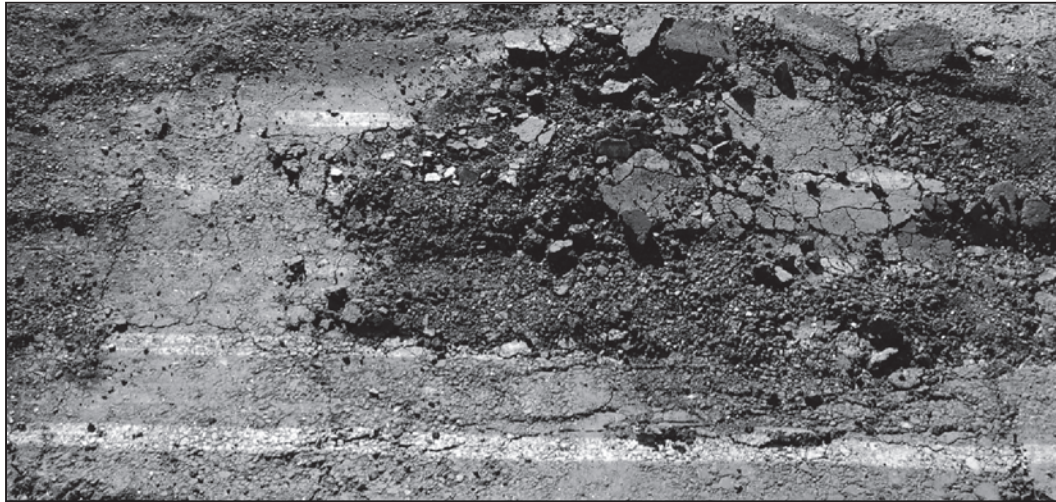
Figure 70. Repair PD-2 after traffic.

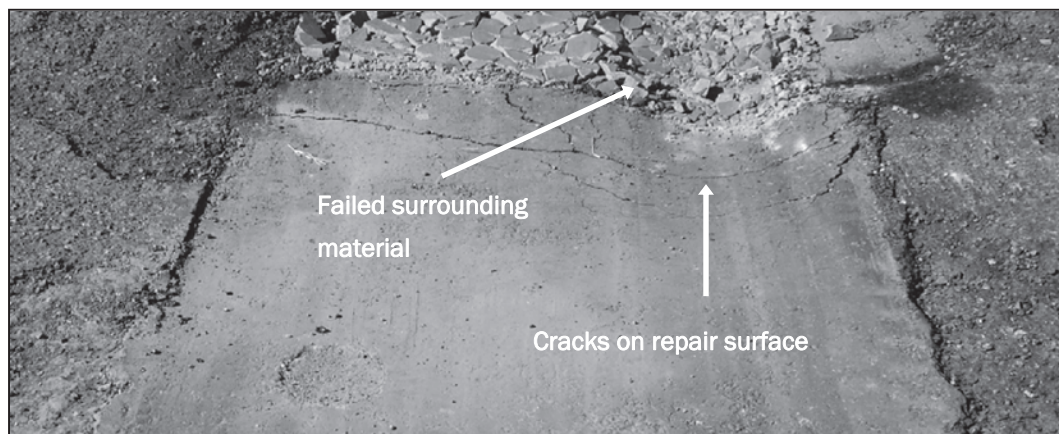
Repair entrance and exit areas relative to traffic direction showed cracking near the edges as shown in Figure 71. This was attributed to deformation of the surrounding asphalt material during traffic. The existing pavement did not provide enough confinement to prevent cracking and failure of the recycled asphalt material in these areas. A factor of failure in the Vicksburg Airport tests site was early subgrade failure and poor surrounding asphalt conditions.

Figure 71. Cracking on repair FD-1 caused by surrounding material failure.

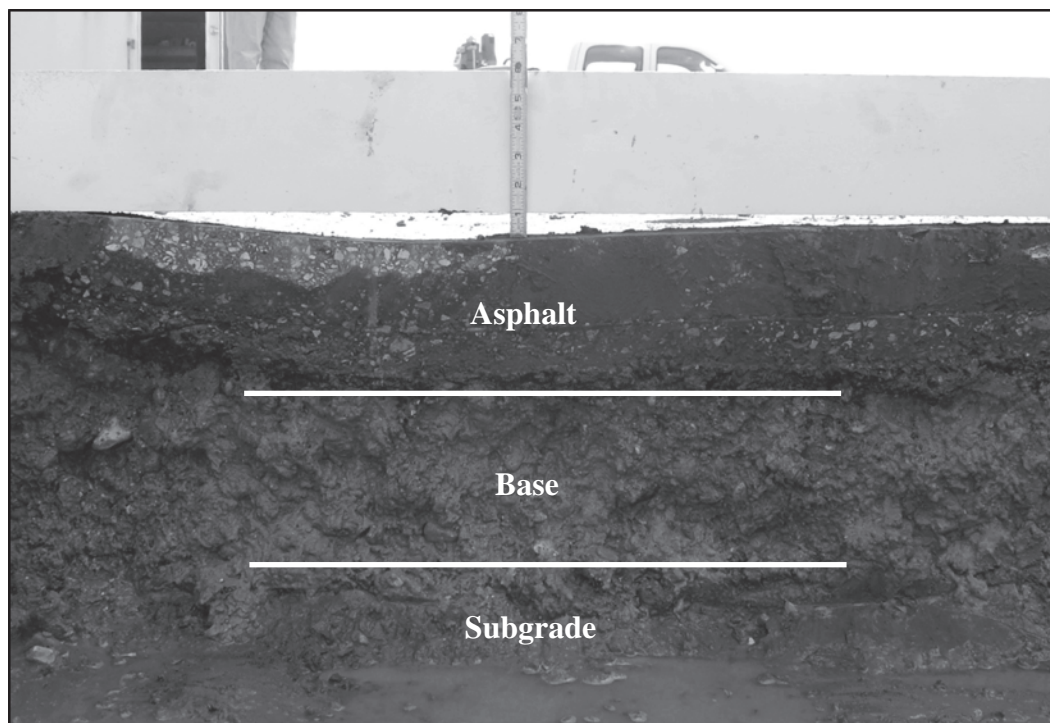
Figure 72. Repair FD-2 trenched cross-section view after failure.

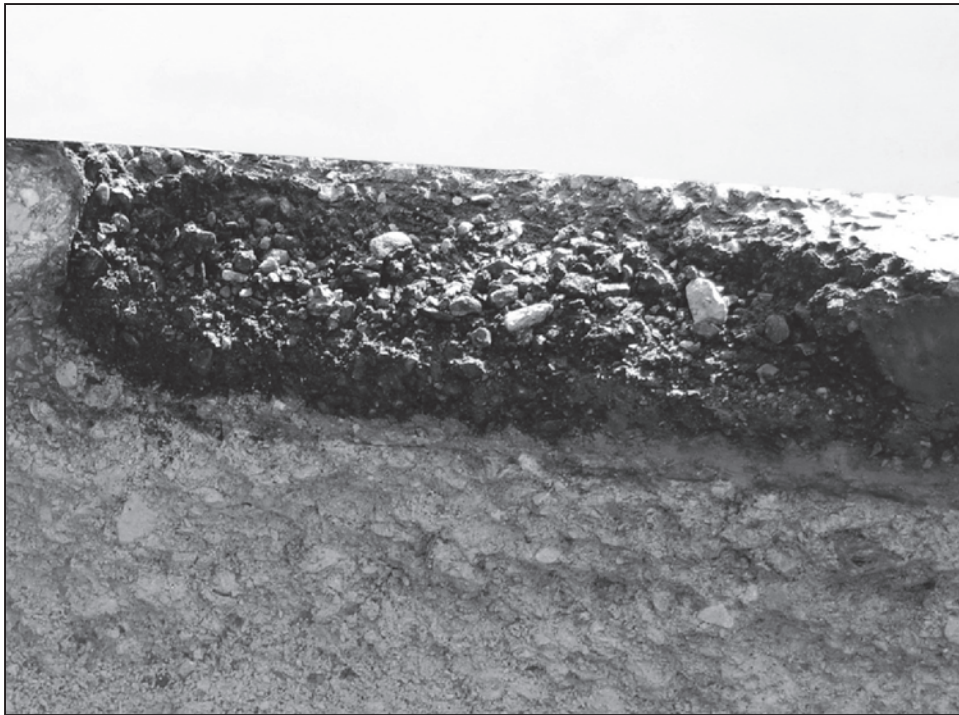
PHP-4 exhibited the greatest rut depth of all four repairs conducted at Test Site 2. Trenching revealed loose material close to one edge (which could be expected for repair edges), but uncoated aggregate was also observed as

Figure 80. Loose recycled asphalt material after repair PHP-4 was trenched. (Note the uncoated aggregates).
